# **What will my Deck look like after 2 years Using a water base coating or A solid membrane coating containing resins & urethanes**

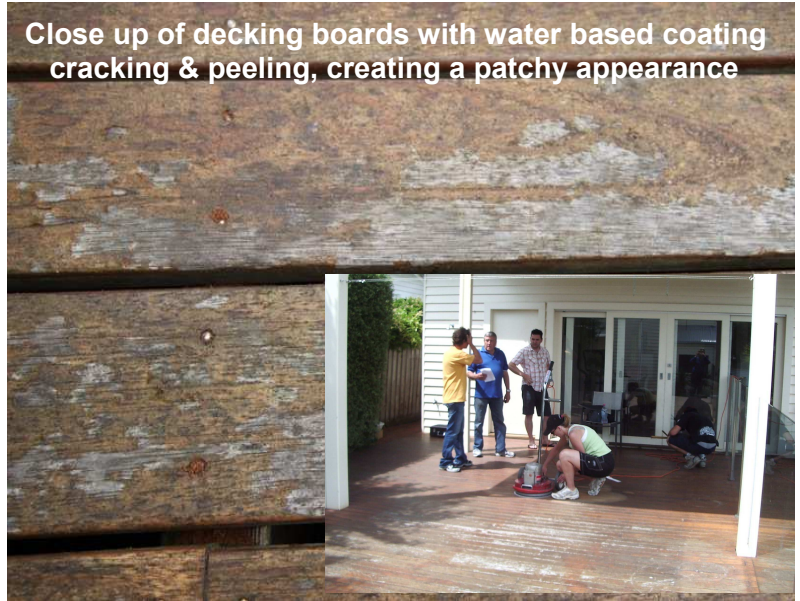
**The artificial colour disguises the natural beauty of the timber (similar to a coat of paint) These coatings leave a solid membrane on the surface which starts to crack & peel off after a short period of time.**

**The timber is then totally unprotected & will absorb water and start to dry out. The timber will loose its natural preserving oils, tannins & colour.**

**Close up of decking boards with water based coating cracking & peeling, creating a patchy appearance**

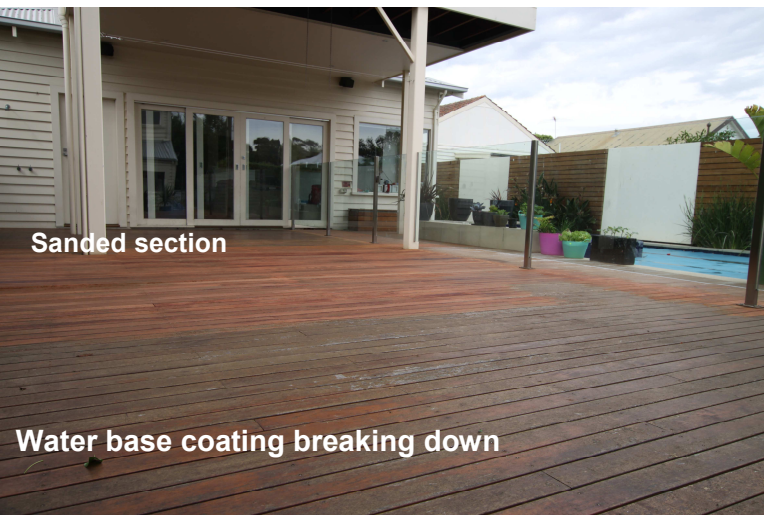
**This shows the finished sanded surface. However in spite of the deep sanding there is some natural colour loss due to the loss of tannins from the timber.**

**Sanded section**

**The whole surface required sanding.**

**All nail heads had to be punched in to a depth of 3-4mm**

**The surface had to be sanded 3-4 mm to restore some original timber colour.**

**It required 80 hours to sand off the water based coating from all surfaces.**

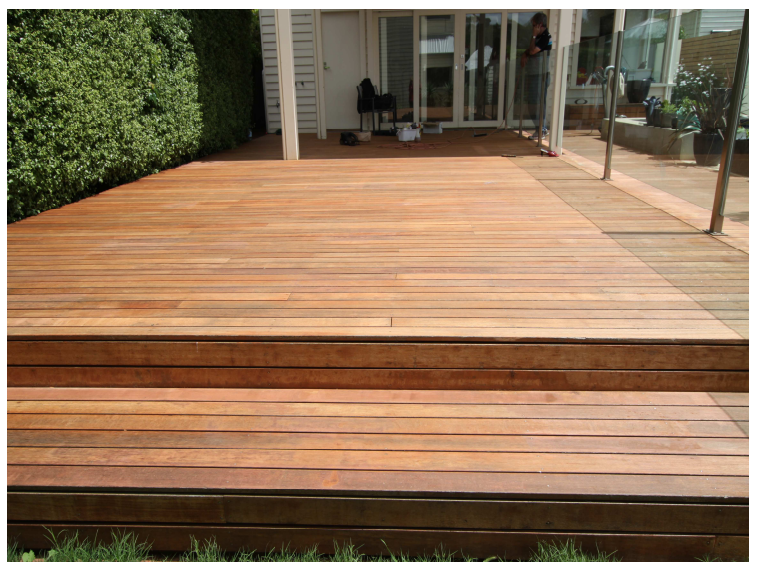
**This picture shows a water based coating breaking down after 12-18 months.**

**Water base coating breaking down**
